Marine Survey Report

Port of Illahee Tire Reef / Fish Haven

November 8, 2023

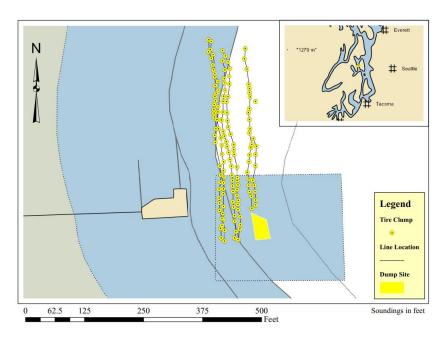
Figure 5: Tire Clump Locations

Through the methods described above a survey was conducted on October 25th, 2023, of the charted tire reef/ fish haven location plus additional buffer to account for charting errors. During this survey six parallel strings of approximately 25 tire bundles were discovered arranged in a north south orientation extending beyond the charted area to the north by approximately 200 ft.

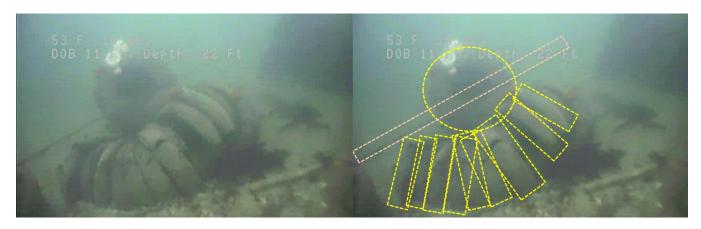
Figure 6: Tire Clump with analysis

Through analysis of the collected sonar imagery and ROV inspection video the survey team estimates a total of 138 tire clumps each with between 12 and 20 tires along with an additional large tire "dump site in the southeast corner of the survey area containing between 600 and 1000 additional tires. Based on this analysis Estimate of the tire quantities are contained in the following table.

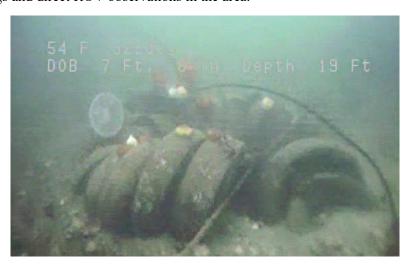
Figure 8: Tire Clump inspection (depth 19ft)

Total charted water depth in the area occupied by the tire reef varies between 20 and 30ft with the shallow area to the west and deeper water located near strings 5 and 6 in the east. Bathymetry was verified with both sonar readings and direct ROV observations in the area.

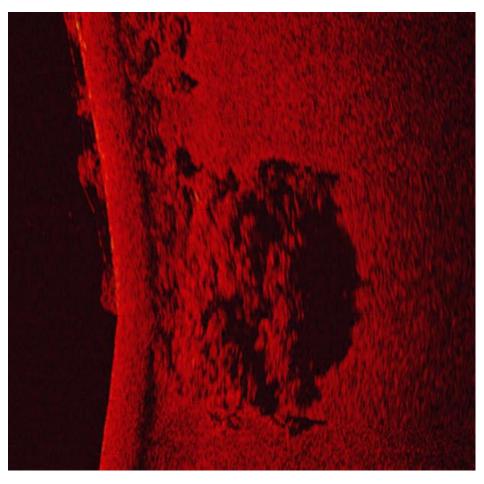
Figure 10: "Dump Site" (Dimensions 36ft x 17ft)

String pair	Number of clumps	Low Estimate	High Estimate
1/2	52	624	1040
3/4	54	648	1080
5/6	32	384	640
*Dump Site	N/A	600	1000
Total	138	2256	3760
This feature was only imaged with sonar and further investigation is warranted

Though we are confident in our estimates in section 3 we were unable to observe the apparent "dump site" in the southeast corner of the impacted area. Our estimate of tire quantities and weight of this feature are therefore of less accuracy than the other areas observed. We recommend a dedicated inspection of this feature be scheduled to further refine our findings.

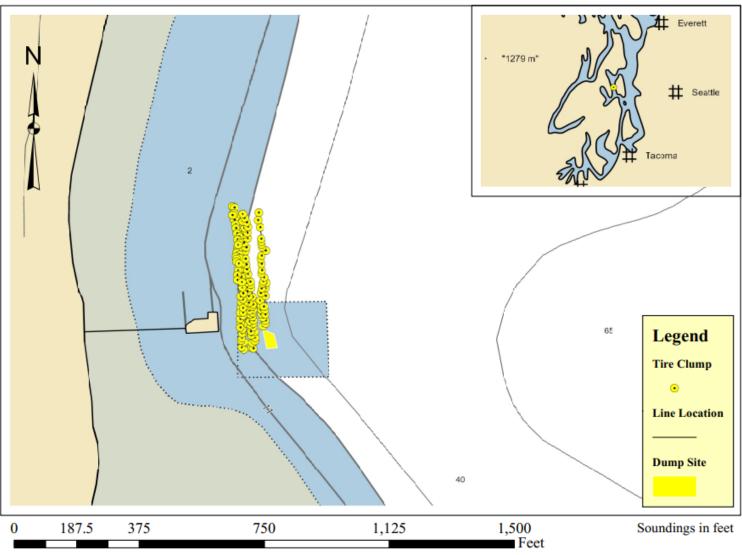
Figure 11 site overview

The charted footprint of the tire reef/ fish haven is rectangular 84m by 68m with the long axis-oriented East/ West. During analysis of the data collected the actual dimensions are approximately 90m by 20m

with the long axis orientation of 355/175 (roughly North/South). The reef footprint is approximately 1.127acres in this area.
