Survey of Specific Items

The Illahee Wharf and Floating Docks

The Port Commissioners - Port of Illahee

June 12th & 13th, 2014

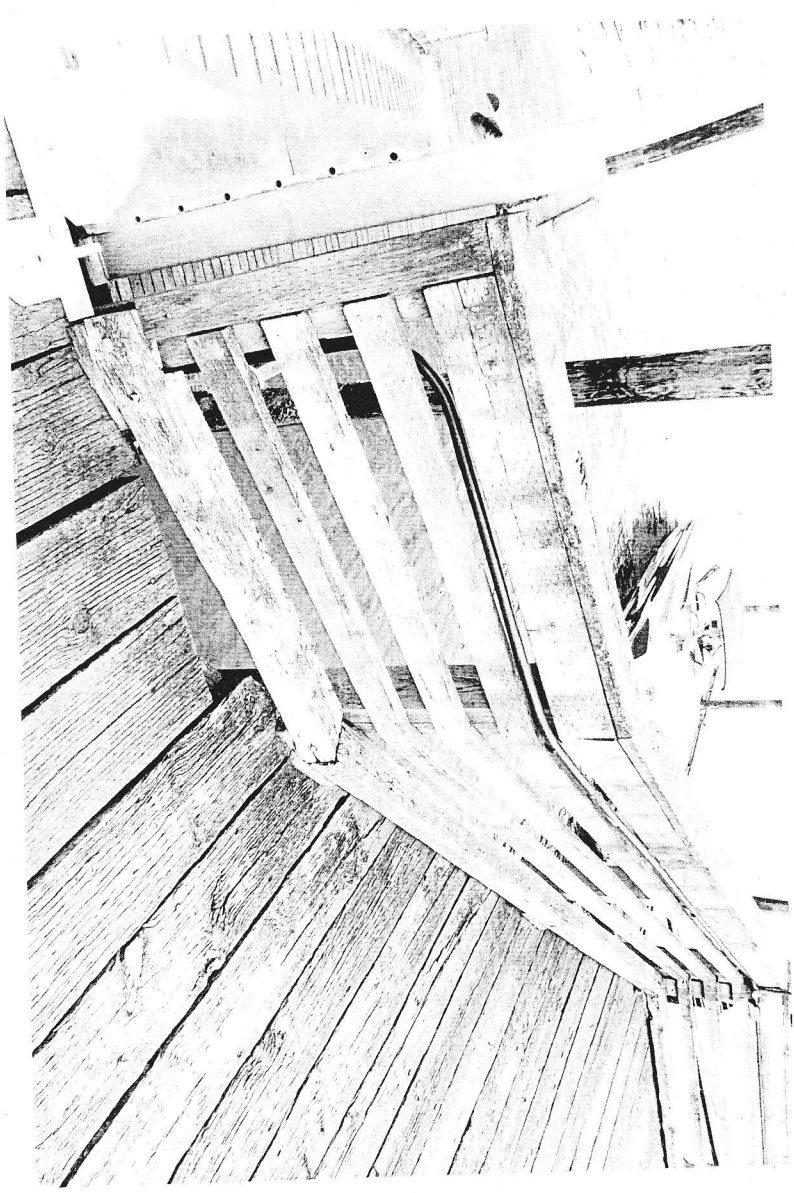
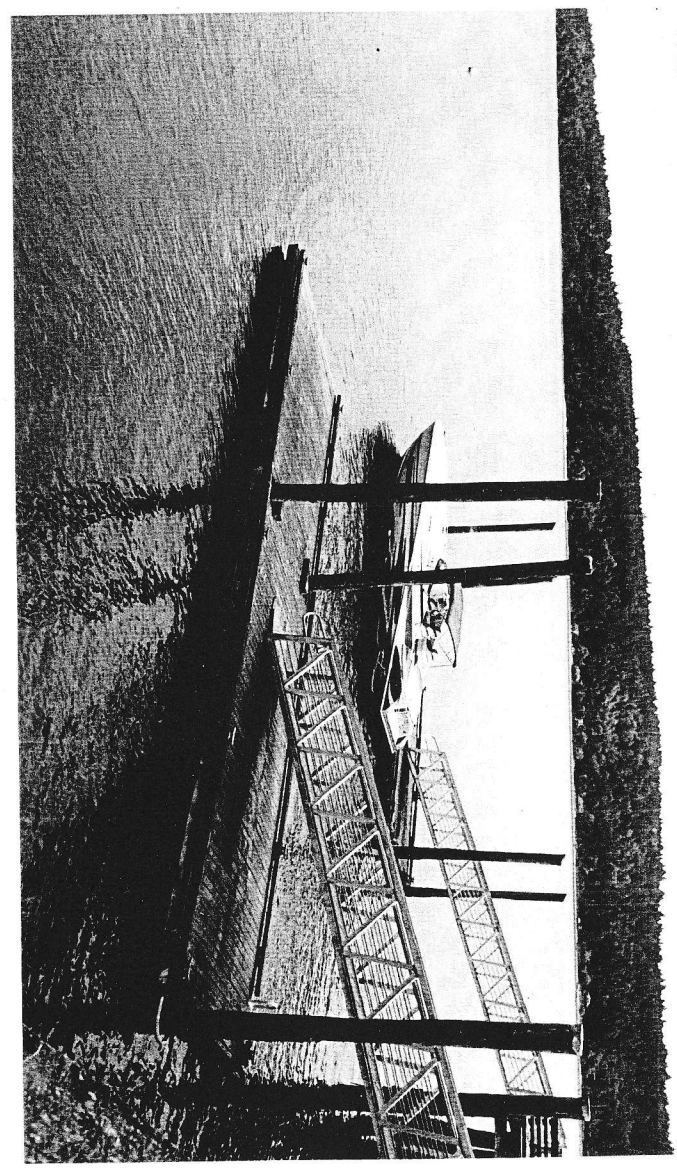
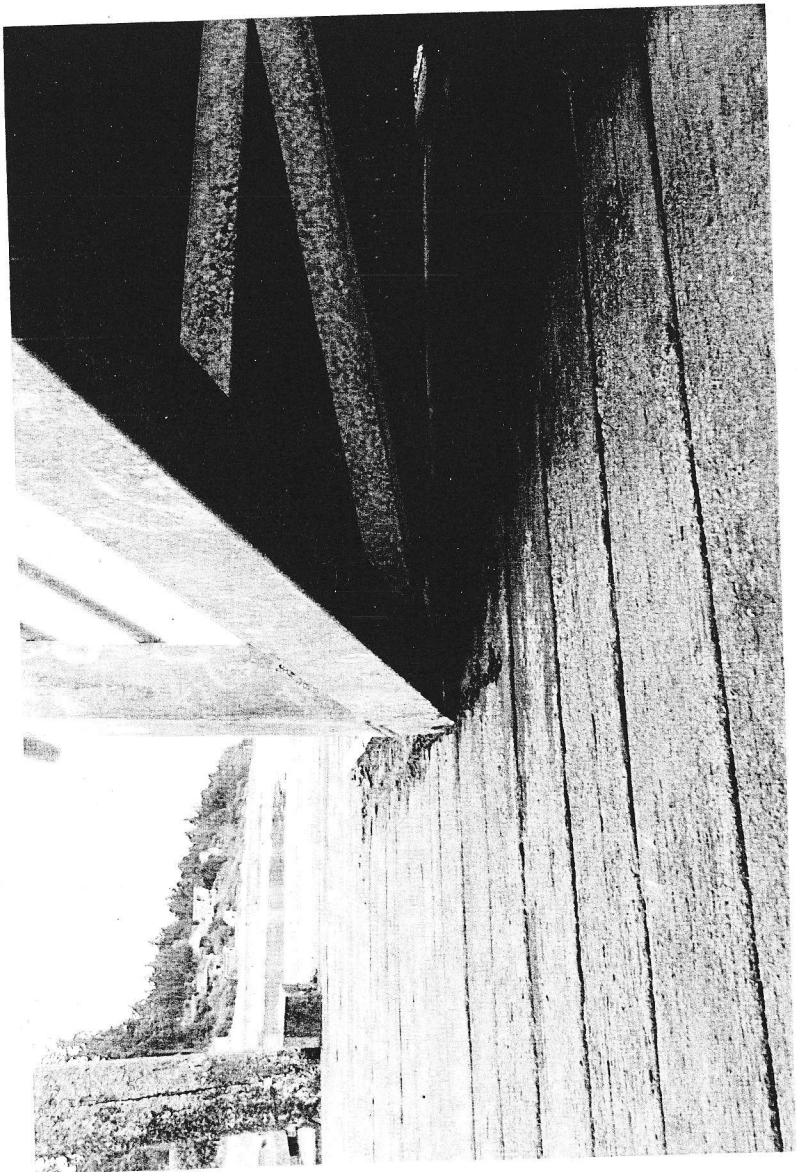
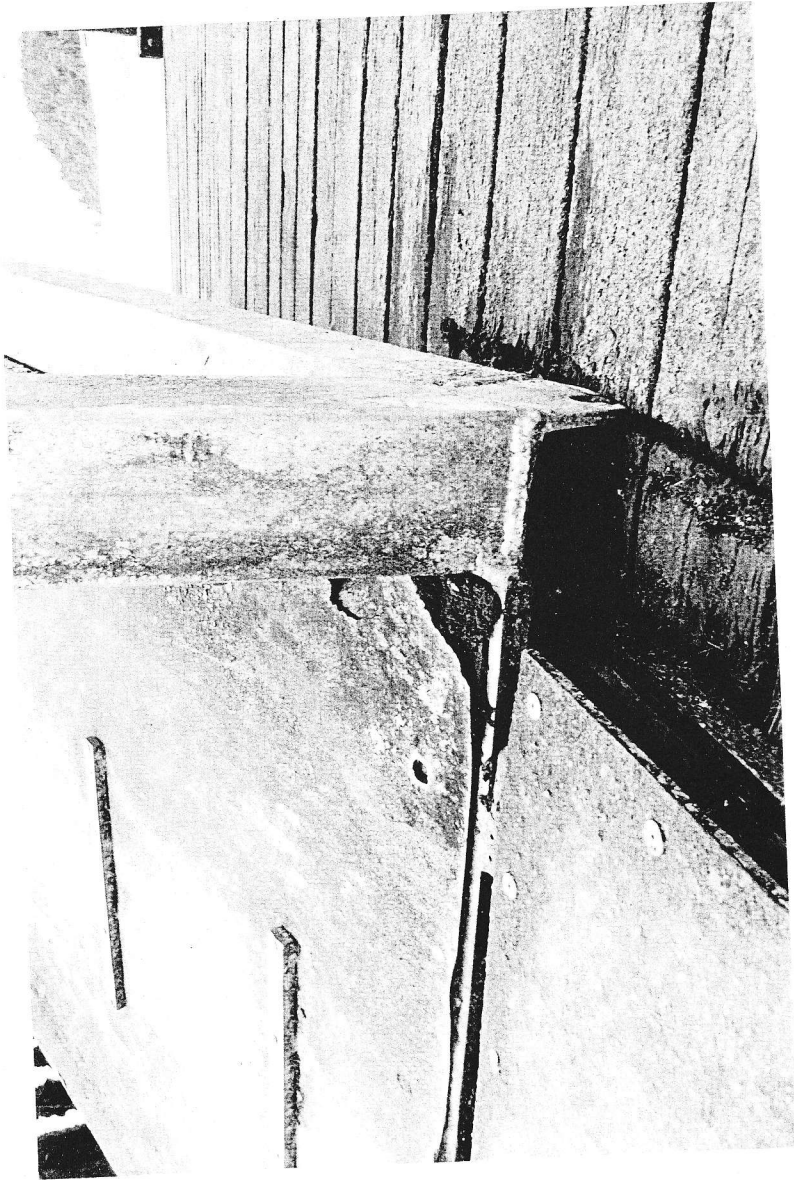
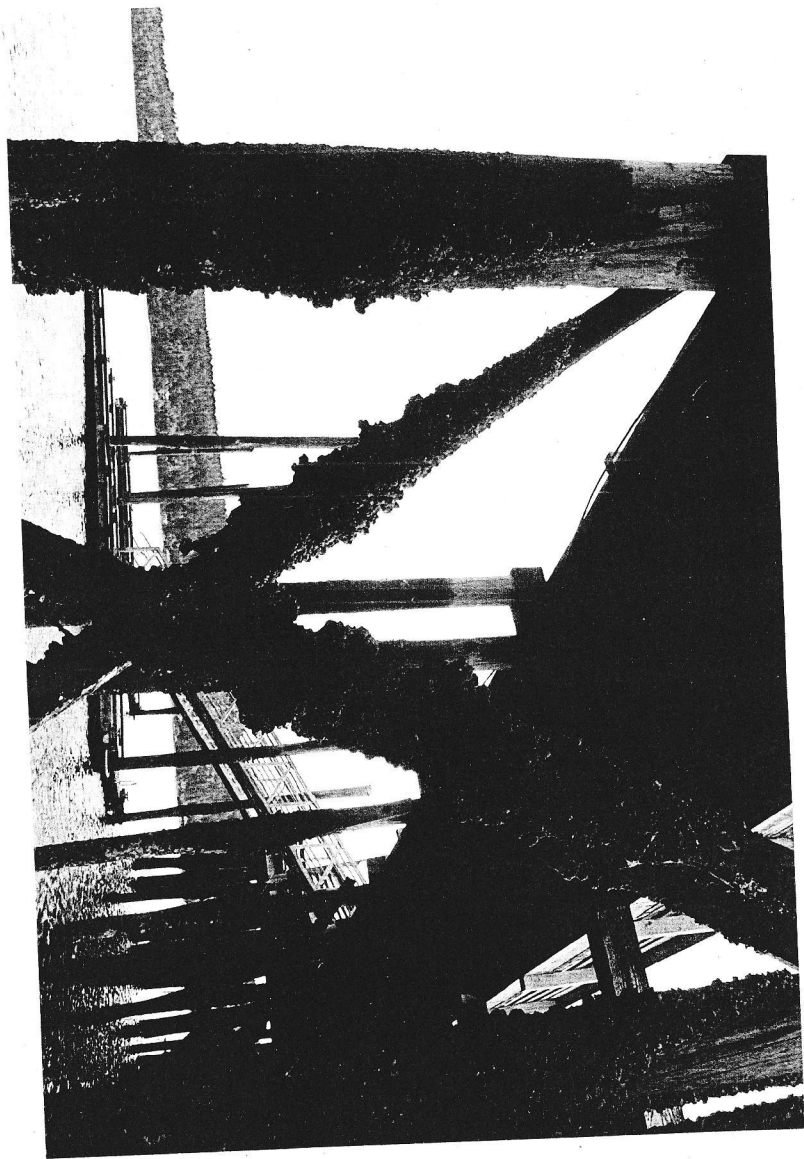
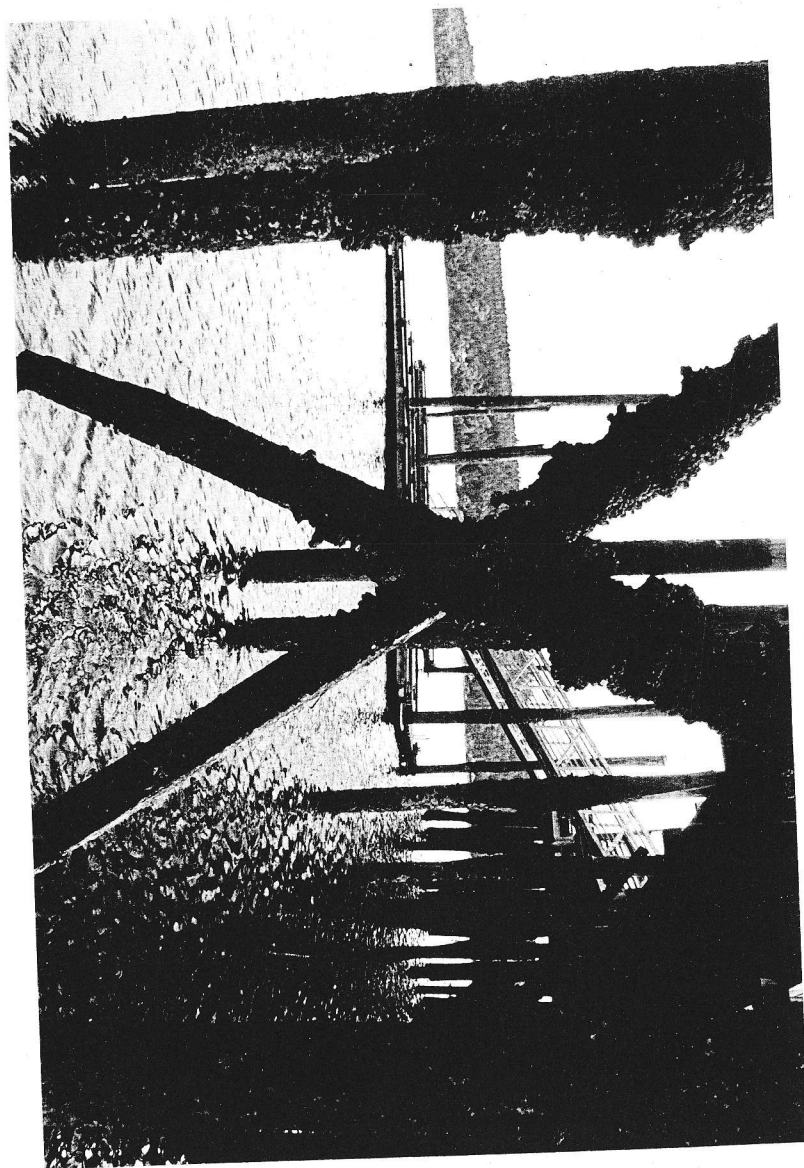
The repair of the existing cross bracing and the construction of additional cross bracing is strongly recommend to be completed this summer. Additional cross bracing was recommended in earlier reports and was not installed. Pictures of the existing cross bracing are included following the appendix.

One of the ramp wheels on floating dock #1 is missing. The wheel should be replaced as soon as possible as damage to the dock decking is being done and if the ramp end was to dig in and be stuck, major damage to the dock, ramp and wharf connection could result. In addition to replacement of the wheel, a guide track of steel angle iron is suggested to be installed under both wheels. A picture of the missing wheel and the digging into the dock is attached.

6. The section of deck railing adjacent to the floating dock #1 ramp needs to be stabilized, It is recommended that a second 4"x4" bottom rail be attached to the existing bottom rail and then nailed directly to the decking. A picture of this railing section is included in the appendix.

4. Cross bracing must be replaced as soon as possible as all existing cross bracing is basically nonfunctional. In addition, new cross bracing should be installed between lines 18 and 19 on both sides of the wharf. It is recommended that two piece cross bracing be through bolted both to the pilings and to each other and that 2"x 8" pressure treated hem/fir with as required blocking between the two pieces be used.

7. The missing wheel on the floating dock #1 ramp should be replace immediately. As noted before if the ramp was to become stuck in the decking, damage to the ramp and ramp to wharf connection could result. In addition, steel angle iron guide tracks are recommend to be installed.
